### 3.6 SPECIMEN PRESSURIZATION

### 3.7 FATIGUE TEST PROCEDURES

### 3.9 SUMMARY OF RESULTS

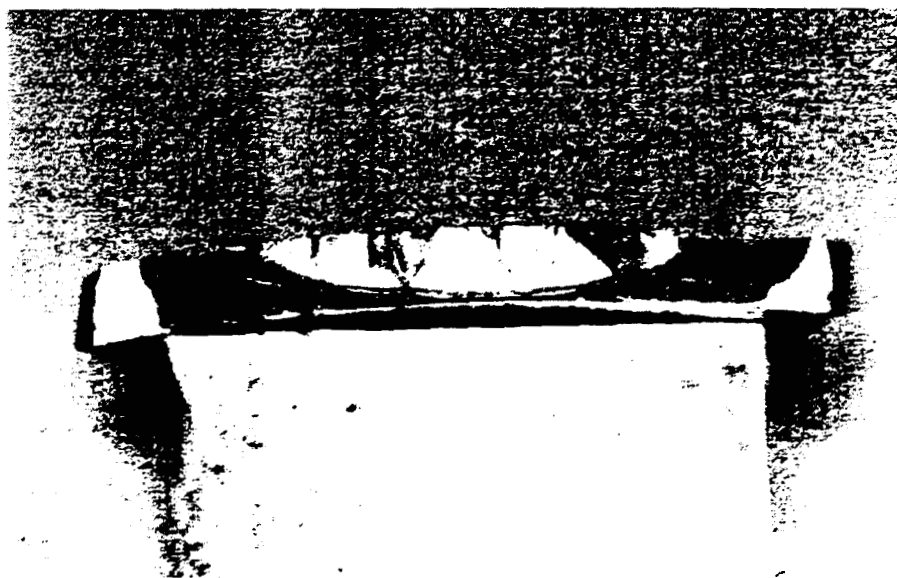
**Figure 3-55:** Exposed crack surface for Dent F, Specimen 7.

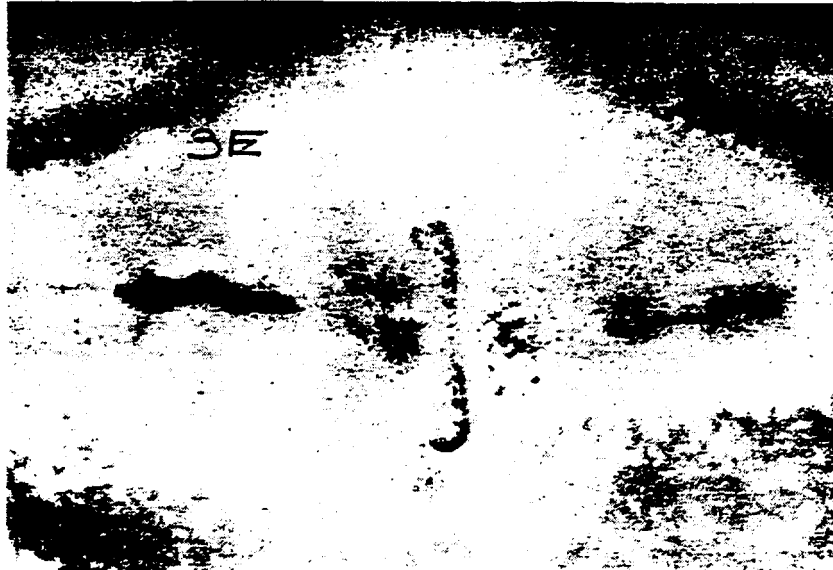
**Figure 3-56:** Periphery cracking at transverse backhoe tooth dent (**Type BH-T**), Dent E, Specimen 3

As shown in Fig. 3-56, similar type periphery cracking developed as in the case with the backhoe tooth dent oriented in the longitudinal direction.
